APPENDIX C

Photograph Log and Photographs

PHOTO LOG

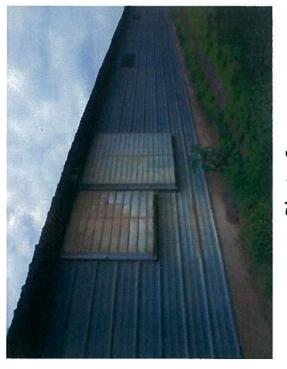
Photo Reference	Photo Filename ¹	Coordinates Where Photo Taken	Description
Photo 1	2011-06-1609.45.28.JPG		GPS unit showing time of 9:33:24 AM.
Photo 2	2011-06-1609.45.37.JPG		(Integrator)
Photo 3	2011-06-1610.33.29.JPG		Chicken House No. 4, front View
Photo 4	2011-06-1610.34.07.JPG		Chicken House No. 4, East View
Photo 5	2011-06-1610.36.26.JPG		Drainage from Co. Rt. 7, leading to culvert that goes under House No. 4. Drainage is flowing west towards South Fork River.
Photo 6	2011-06-1610.39.03.JPG		Sidewall ventilation, east side of House No. 4
Photo 7	2011-06-1610.40.04.JPG		Hose to flush drinking water system. House No. 4, east side.
Photo 8	2011-06-1610.41.04.JPG		South side entrance of House No. 4.
Photo 9	2011-06-1610.42.34.JPG		Culvert influent
Photo 10	2011-06-1610.43.08.JPG		Ditch line on east side of House No. 4, discharges through this culvert at farm access road, west of House No. 4.
Photo 11	2011-06-1610.45.36.JPG		Discharge from culvert that flows under House No. 4 (see Photo 5). Flows into pond.

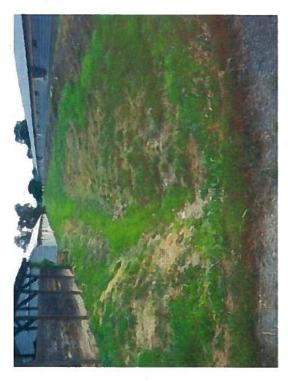
Photo 12	2011-06-1610.46.49.JPG		Overall view of pond located west of No. 4 and south of No. 3.
Photo 13	2011-06-1610.47.36.JPG		Runoff ditch to pond between No. 4 and No. 3.
Photo 14	2011-06-1610.48.11.JPG		Access road between No. 4 and No. 3. Drains to pond.
Photo 15	2011-06-1610.49.17.JPG		South side entrance to House No. 3.
Photo 16	2011-06-1610.50.17.JPG		Drainage between House No. 3 and No. 2.
Photo 17	2011-06-1610.50.47.JPG		Outlet via culvert from drainage between House No. 3 and No. 2.
Photo 18	2011-06-1610.51.56.JPG		Compost shed located southeast of House No. 2.
Photo 19	2011-06-1610.52.25.JPG		Overall view of compost shed looking south.
